### Background:

In 2007, there was a major maritime disaster in the Aegean Sea, which resulted in the sinking of a large cruise vessel. The vessel had significant quantities of fuel oil as well as other hydrocarbons, lubrication oil and cooking oil etc.

A major Greek responder has been contracted to protect the area and keep any escaping oil contained and recover it. The booms are permanently deployed using a boom mooring arrangement of floats and anchors.

Up to 250m of Vikoma HI Sprint boom, at each time, has been permanently deployed around the sunk vessel since 2007. The booms are deployed from 3 to 6 months before they are removed for cleaning and maintenance and any damaged booms are repaired or replaced.

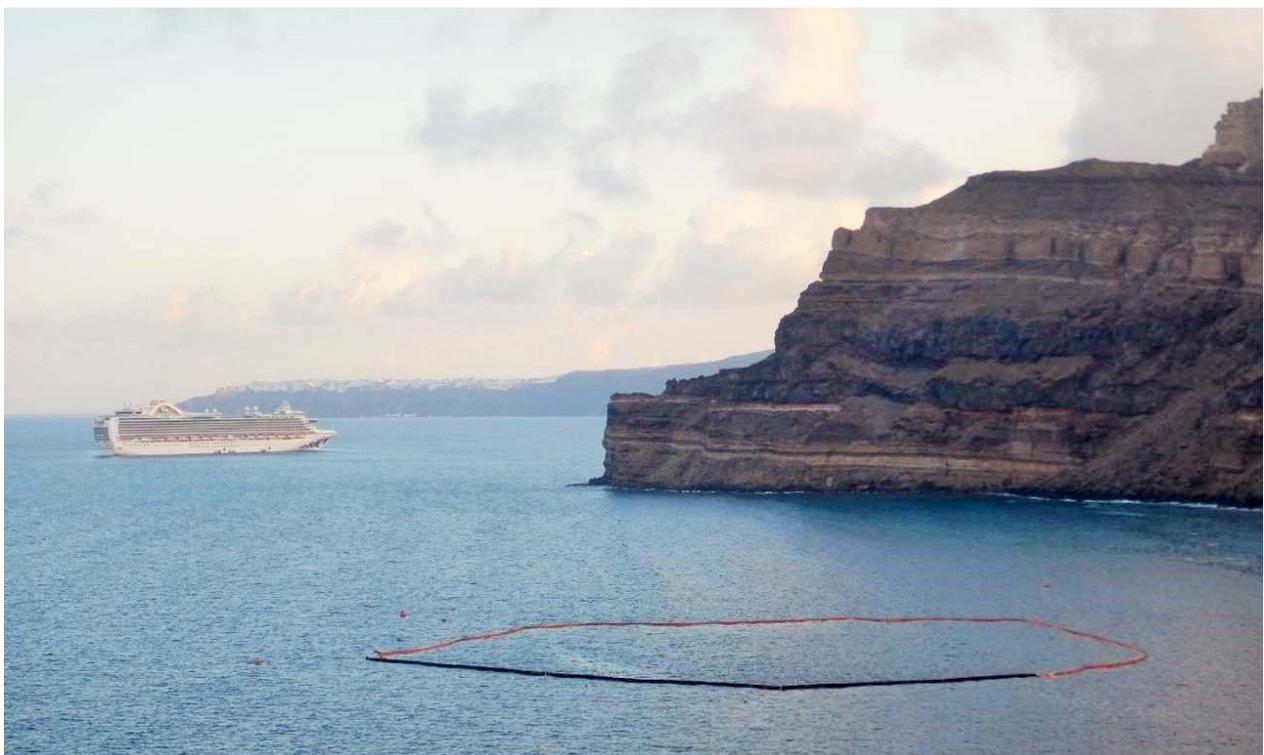
*Above: Vikoma Hi sprint deployed above sunken cruise ship*

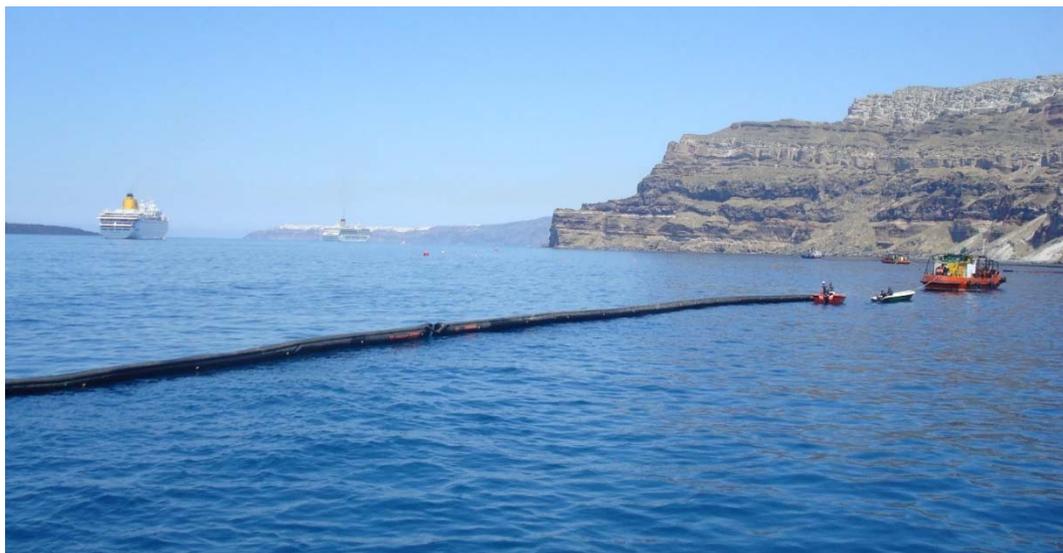
*Left: Hi sprint boom being deployed, quickly with single point inflation*

Every few months the booms are recovered and taken ashore for cleaning with high-pressure washers and any marine growth is removed. The booms are then inflated, tested and redeployed to the site.

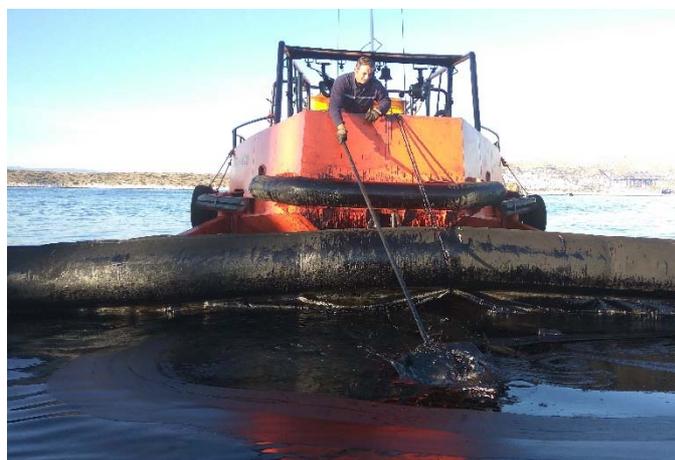
*Below: Oil contained by HI Sprint*
